Sunshine Canyon Landfill

ARCHITERRA design group landscape architecture and planning

CONCEPTUAL LANDSCAPE MASTER PLAN

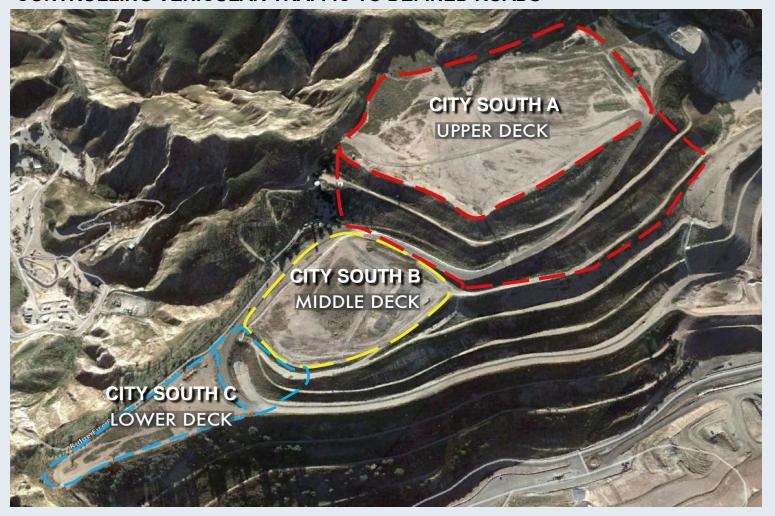
- MINIMAL GROWTH OF COASTAL SAGE SCRUB MITIGATION
- DOMINATED BY BARE SOIL AND INVASIVE GRASSES AND WEEDS
- HEAVILY COMPACTED SOILS WITH POOR STRUCTURE AND LIMITED NUTRIENTS
- ON-GOING MAINTENANCE CONDUCTED BI-ANNUALLY
- EXISTING IRRIGATION SYSTEM IS LIMITED TO CERTAIN AREAS (PM-10 BERM)
- CONTROLLING VEHICULAR TRAFFIC TO DEFINED ROADS

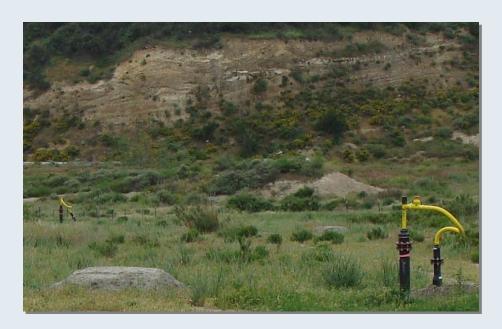
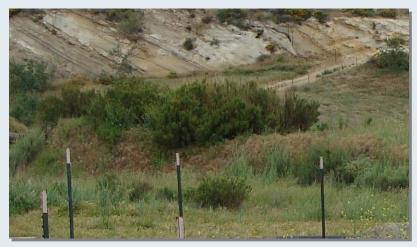
RECAP OF EXISTING CONDITIONS:

SOME NATIVE SPECIES ON EXISTING MOUNDS VS. FLAT COMPACTED BARREN PAD AREAS

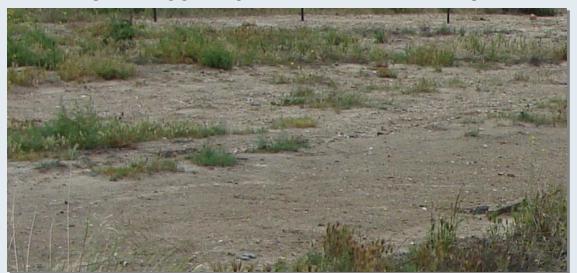
NATIVE GRASSES PRESENT IN DRAINAGE RIVULETS

- MAINTAIN DECK DRAINAGE PATTERNS WITH MINIMAL ALTERATION
- PROVIDE POSITIVE DRAINAGE TO COLLECTION DRAINS
- STABILIZE AREAS OF CONCENTRATION WITH BOULDERS/COBBLE IF NECESSARY

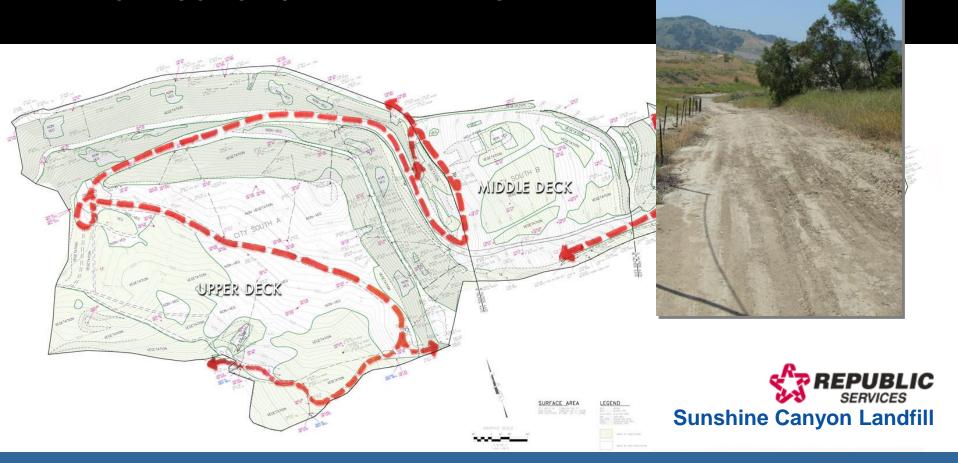
- IDENTIFY VEHICULAR CIRCULATION PATTERNS
- CONTROL ACCESS ONTO DECKS AND LIMIT VEHICLES TO ROADWAYS
- PROVIDE BARRIER PROTECTION WHERE NEEDED

• PROVIDE SIGNAGE TO HELP IDENTIFY AREAS

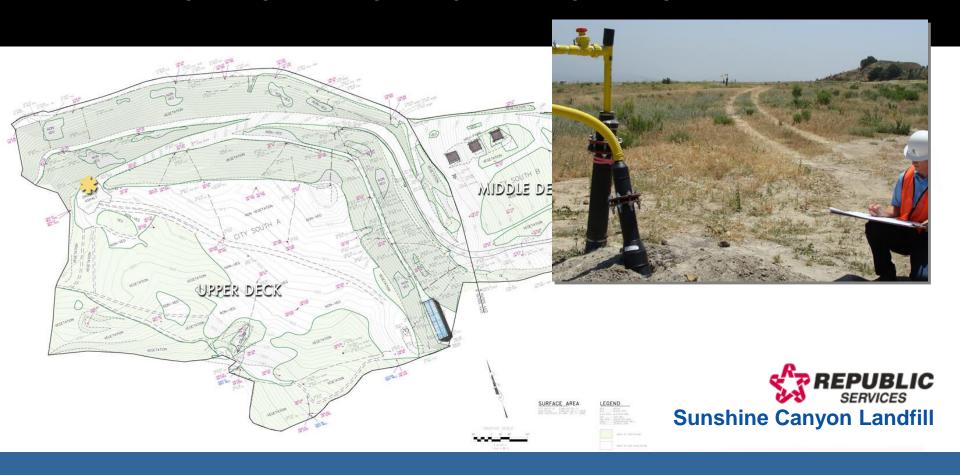
EXISTING FEATURES/STRUCTURES

- IDENTIFY EXISTING FEATURES (OBSERVATION DECKS, HELI-PADS, NURSERY, ETC.
- IDENTIFY DECK GAS WELLS, TANKS, PIPING, ETC.
- REVIEW REQUIRED ACCESS ROUTES TO FEATURES/STRUCTURES
- MAP PIPING AND POTENTIAL CONFLICTS WITH IMPROVEMENTS

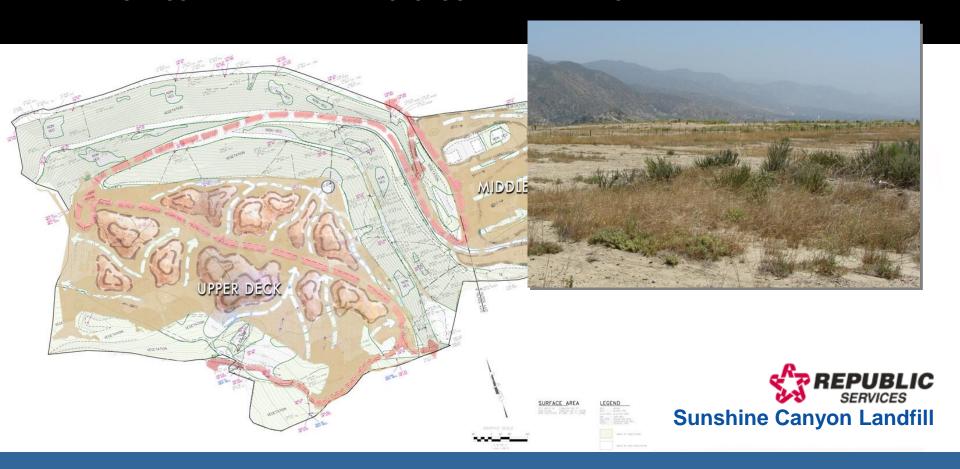
EXISTING SOIL CONDITIONS

- EVALUATE EXISTING VEGETATION FOR PROTECTION
- MAP AREAS FOR CROSS RIPPING EXISTING SOIL TO 12" DEPTH
- TAKE SOIL SAMPLES FOR AMENDMENT RECOMMENDATIONS
- IMPORT SOIL AND CREATE MICROTOPOGRAPHY BERMING

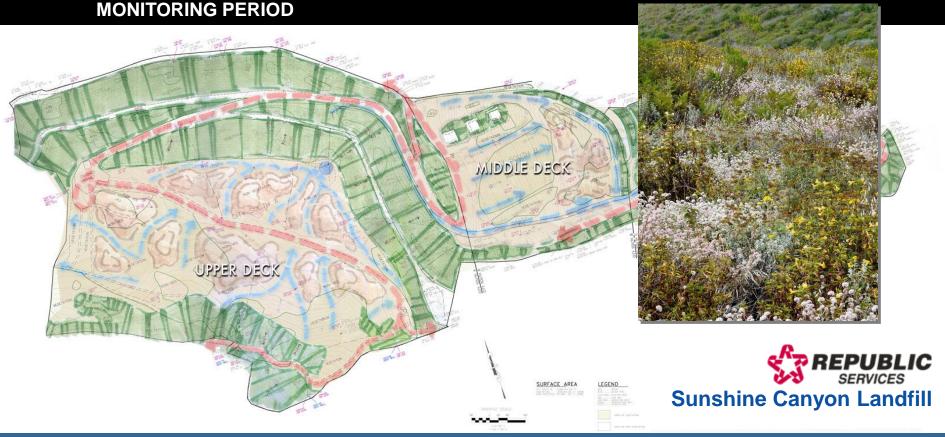
REVEGETATE SLOPES AND DECKS

- WEED ERADICATION PROGRAM (HAND/CHEMICAL) TO MINIMIZE COLONIZED NON-NATIVES
- PROVIDE TEMPORARY IRRIGATION SYSTEM (2-3 YEARS) TO HELP WITH INITIAL KILL/GROW CYCLE AND FUTURE ESTABLISHMENT OF NATIVES
- HYDROSEED AND PROVIDE CONTAINER PLANTING PROGRAM

MONITOR AND PROVIDE MORE FREQUENT MAINTENANCE DURING ESTABLISHMENT AND

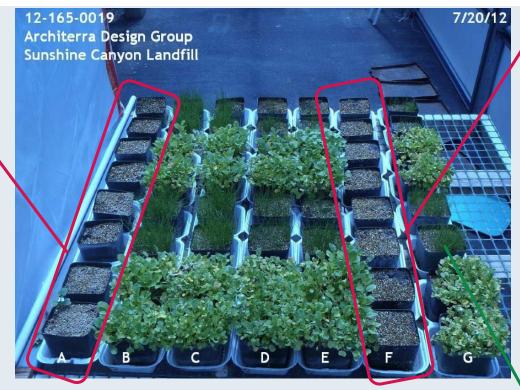
A2, B1, B2 & C1

(SLIGHTLY HIGH IN SALINITY, **LEACHING BY IRRIGATION)** A1 & C2 **B2 & C1** (LOW ON PHOSPHORUS)

SEDIMENTATION BASIN SOIL (LOW ON PHOSPHORUS & NEEDS SOIL SULFUR)

(ELEVATED SALINITY, STRONGLY ACIDIC)

Salinity (ECe) is very high and was measured at 16.0 dS/m. Few plants would be expected to become established. The greatest contributors to salinity in this sample are very high soluble magnesium and sulfate. The reaction of the soil is very strongly acidic at 3.6 on the pH scale. Few plants would be expected to tolerate this level of acidity. Boron is elevated at 1.32 parts per million (ppm). Under other conditions, this could cause some plants to show tip burning of older leaves but in this case, boron is a minor concern compared to the salinity and pH values. Based on the high salinity, sulfates and magnesium, along with a very low pH, this soil appears to be derived from the Capistrano formation. This will be discussed further in the comments section below.

Salinity is elevated in the 'A1 Top Deck' sample at 5.9 dS/m, which is high enough to have a negative effect on the growth performance of a broad range of plants. High soluble magnesium and sulfate are the greatest contributors to salinity in this sample and, along with a relatively low pH, suggest that this soil may be at least partially derived from the Capistrano formation. Thorough leaching irrigations should be applied in this area as described above. We estimate that approximately 3 inches of leaching should bring salinity to a safely low level in the root zone. The subsoil will likely remain saline and salt tolerant plants should be avoided. Consult with your plant provider regarding the salinity tolerance of specific native plants.

Salinity is slightly elevated in the no4 'B2 Mid Deck' and 'C1 Bottom Deck' samples at 3.0 dS/m and 3.7 dS/m, respectively. These levels of salinity could cause some tip burning on the older leaves of salt sensitive plants. However, these values are not especially high and two or three thorough irrigations in those areas should be sufficient to bring salinity to a safely low level in the root zone.

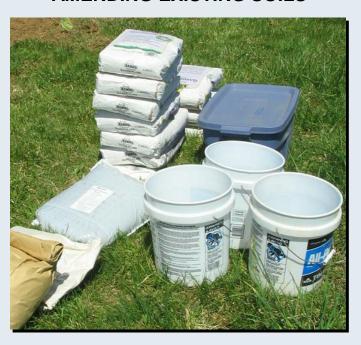
AMENDING EXISTING SOILS

Calcium Carbonate Lime (to increase soil pH @ 150lbs. Per 1,000 sq. ft.)

<u>Triple Phosphate</u> (Incorporated into the final cover of Sediment Basin import @ 2.5lbs. Per 1,000 sq. ft. to a depth of 6")

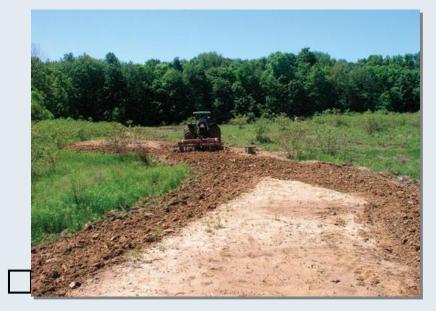
CROSS RIPPING OF EXISTING SOILS TO 12" DEPTH

BENEFITS:

- LOOSENS COMPACTED SOILS
- AERATES SOILS AND IMPROVES SOIL TEXTURE AND POROSITY
- PROVIDES INCREASED WATER
 AVAILABILITY TO ROOTS
- ALLOWS FOR LEACHING TO REDUCE SALINITY OF SOILS AT SURFACE

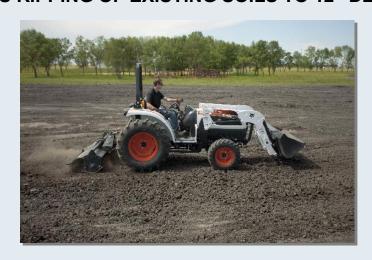
MIXING AND BLENDING OF AMENDMENTS

BENEFITS:

- HELPS ADJUST AND CORRECT DEFICIENCES IN SOIL
- PROVIDES BEST CONDITIONS FOR NEW PLANTINGS
- MINIMIZES HYDROPHOBIC SOIL
 CONDITIONS

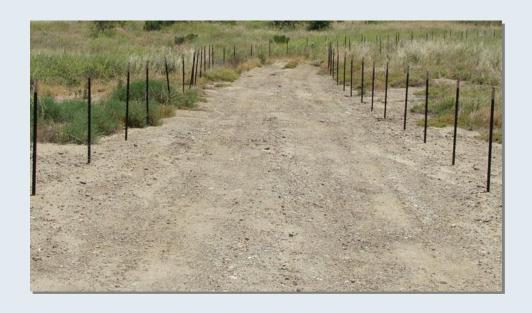
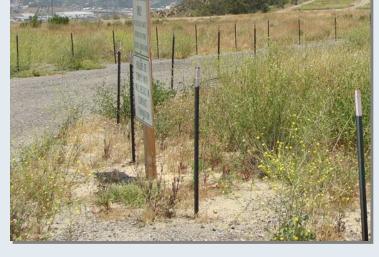
T BAR POSTS AND SIGNAGE

- ELIMINATE COMPACTION OF SOILS
- PROVIDE DEFINED ACCESS ROADS
- GATES LIMIT ACCESS TO AUTHORIZED PERSONNEL ONLY
- SIGNAGE TO HELP EDUCATE PERSONNEL
- PROTECTS SENSITIVE HABITAT

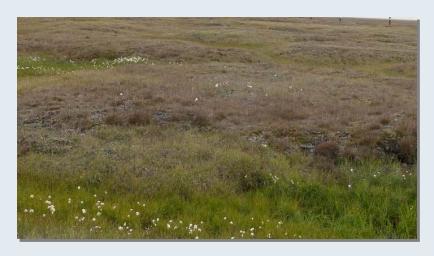
EXAMPLE OF MICROTOPOGRAPHY BERMING

BENEFITS:

- PROVIDES DEEPER ROOT ZONE
- OPPORTUNITY FOR ESTABLISHING PLANT SPECIES DIVERSITY
- ELIMINATE PONDING EFFECT ON DECKS

AND PROVIDE POSITIVE DRAINAGE
- MIMICS MORE NATURAL APPEARANCE OF PLANT COMMUNITY

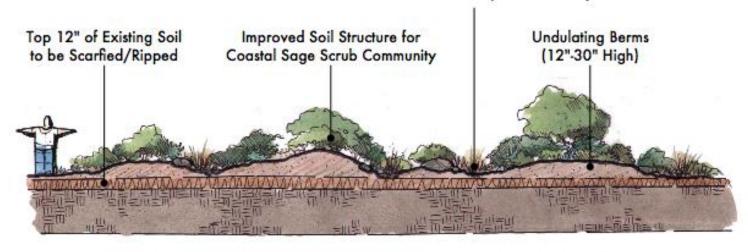
Proposed Microtopography Berming Section

Existing Compacted Pad Section

Small Drainage Rivulets/Swales
Create Opportunity for
Microclimates and Species Diversity

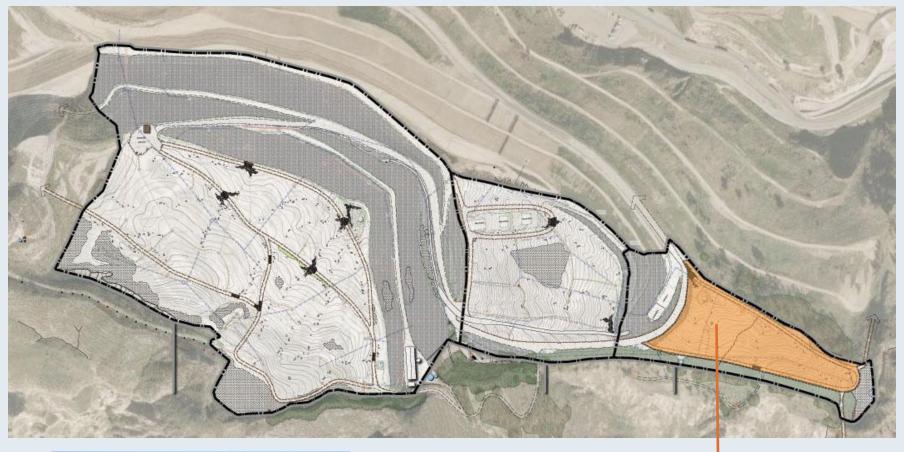
TRIAL SITE 4.67ACRES

ESTABLISHMENT OF TRIAL SITE

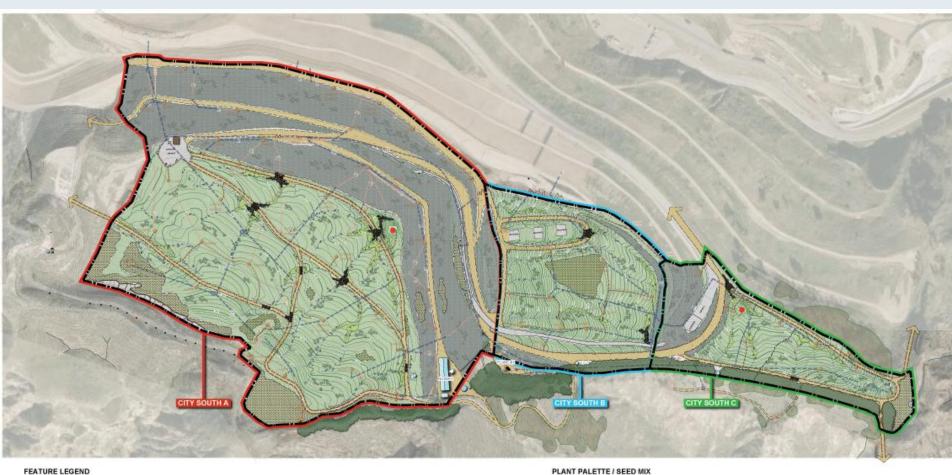
- IMPROVE EXISTING SOIL CONDITIONS
- RESTRICT AND LIMIT VEHICLE ACCESS TO PADS
- CREATE MICRO-TOPOGRAPHIC CONDITIONS TO INCREASE THE VARIABILITY FOR SUCCESSFUL REVEGETATION
- ESTABLISH TRIAL PLOT SITE FOR ANALYSIS
- SUPPLEMENT ANNUAL PRECIPITATION WITH TEMPORARY IRRIGATION SYSTEM TO HELP WITH ESTABLISHMENT OF NATIVE PLANT SPECIES
- TEST VARIOUS METHODS FOR PLANT ESTABLISHMENT AND EVALUATE TO DETERMINE BEST APPROACH FOR FUTURE SITES
- INCREASE FREQUENCY OF MAINTENANCE
